### **Hazardous Materials Sampling Data and Abatement Report**

**Re: Soil Analytical Results  
Whitecotton Cottage NOA Sampling  
15400 Foothill Blvd,  
San Leandro, CA 94578  
ACC Project Number: 2062-327.00**

# White Cotton Cottage Asbestos Abatement & Lead Hazard Control

**White Cotton Cottage  
15400 Foothill Boulevard  
San Leandro, CA 94578**

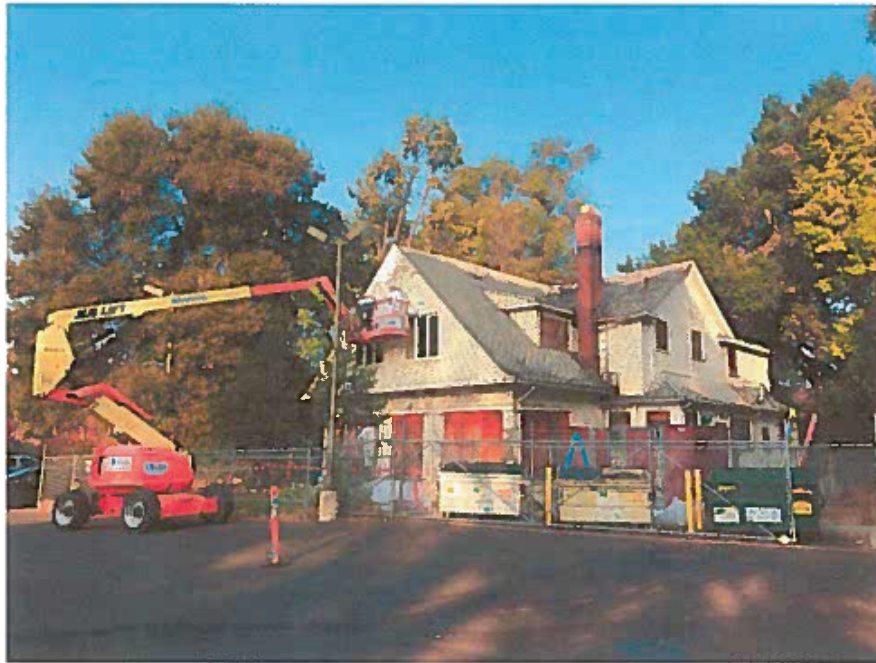
**Photo 1 – Using telescopic manlift to scrape upper section of White Cotton Cottage**

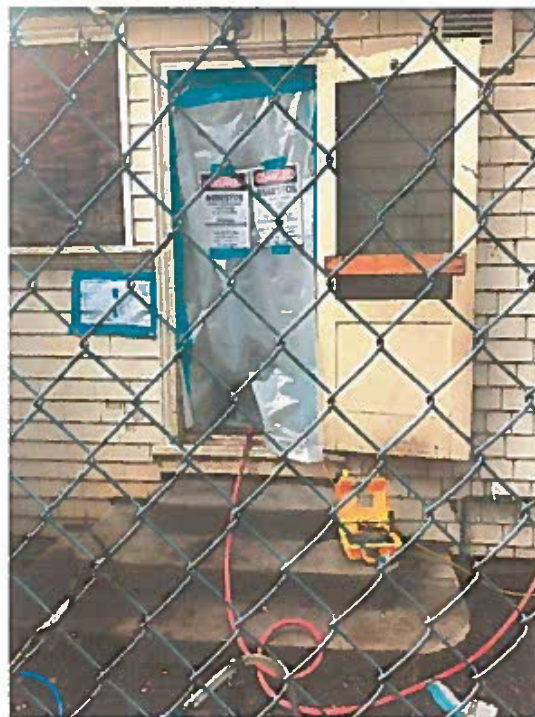
**Photo 2 – Entry to containment**

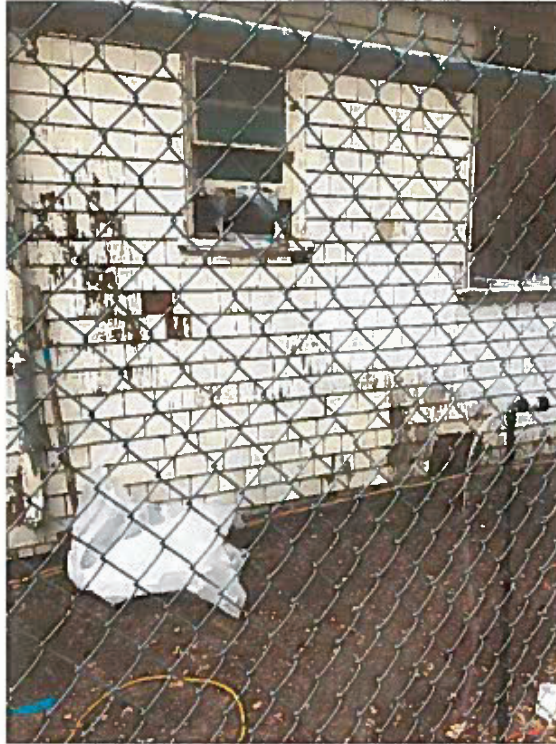
**Photo 3 – Containment exhaust port**

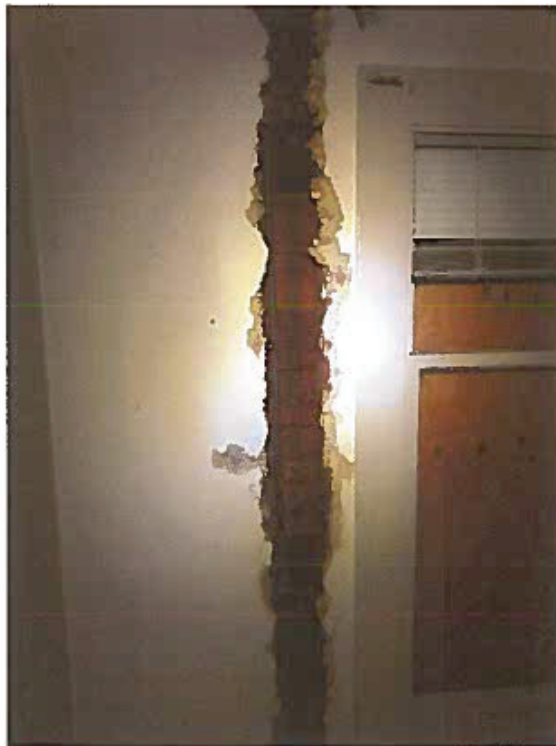
**Photo 4 – Removal of 12 feet of radiator pipe insulation: first story**

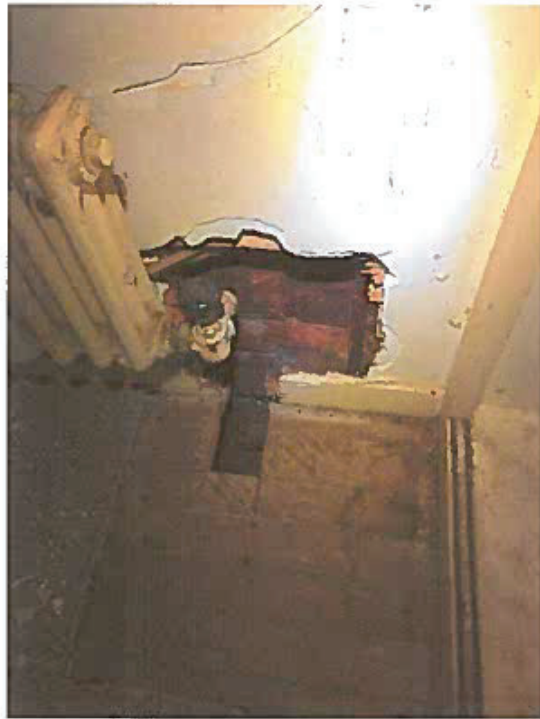
**Photo 5 – Removal of 12 feet of radiator pipe insulation: second story**

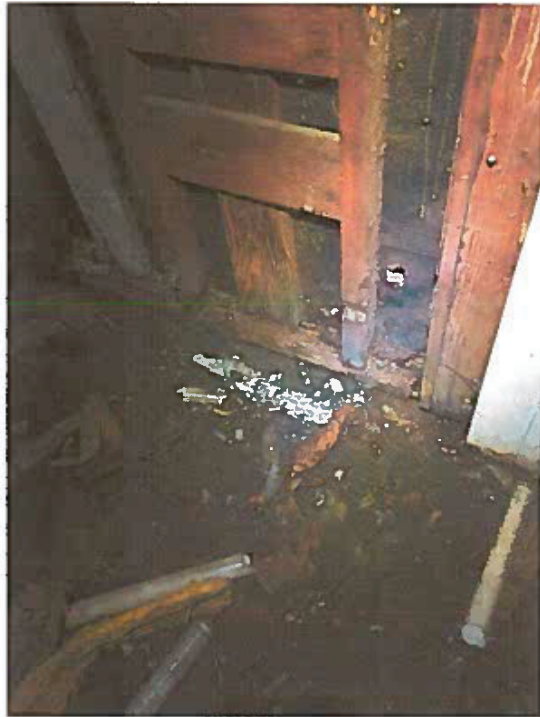
**Photo 6 – Removal of 2 feet of pipe insulation: Basement**

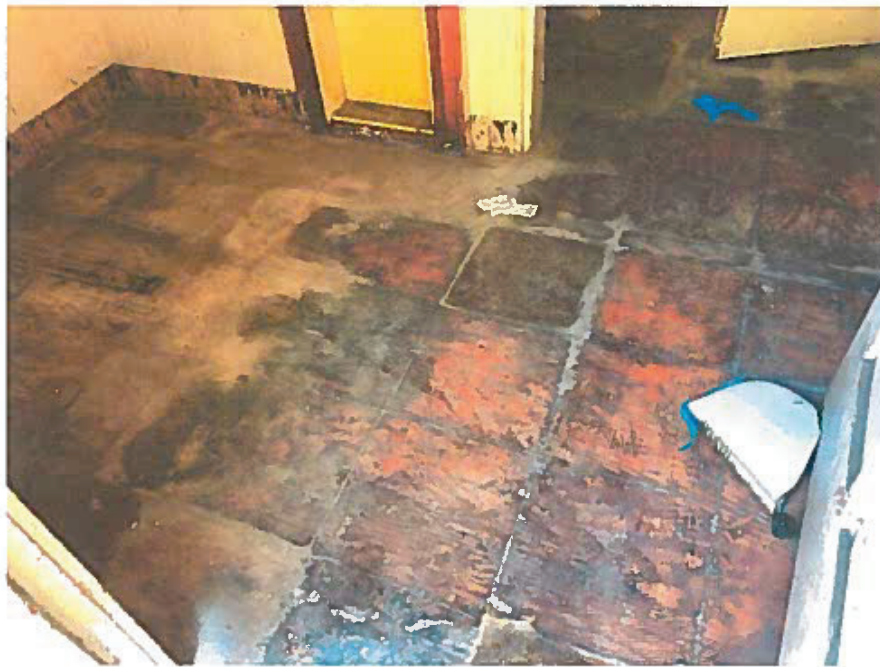
Photo 7 – Laundry Room post-abatement

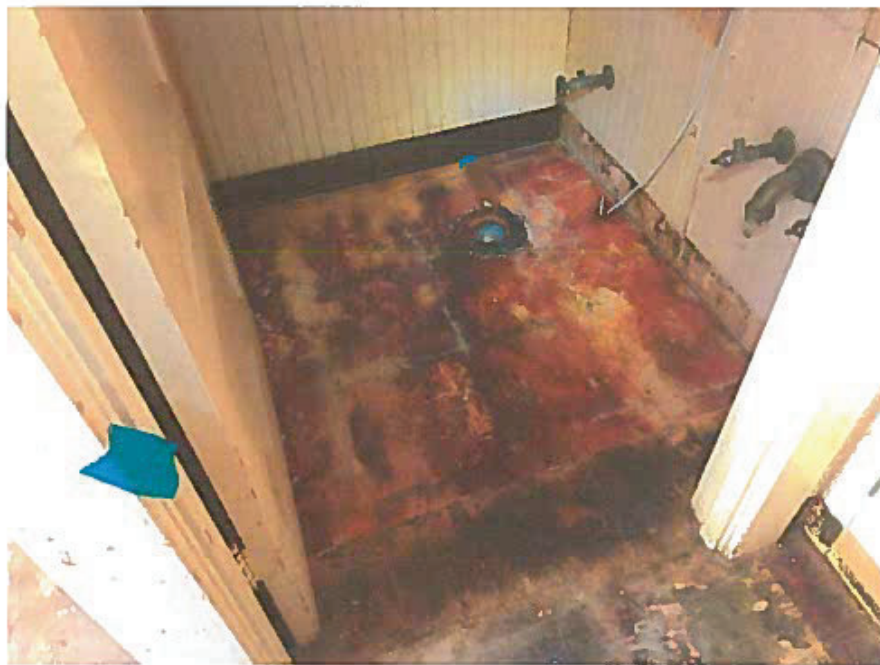
Photo 8 – Bathroom post-abatement

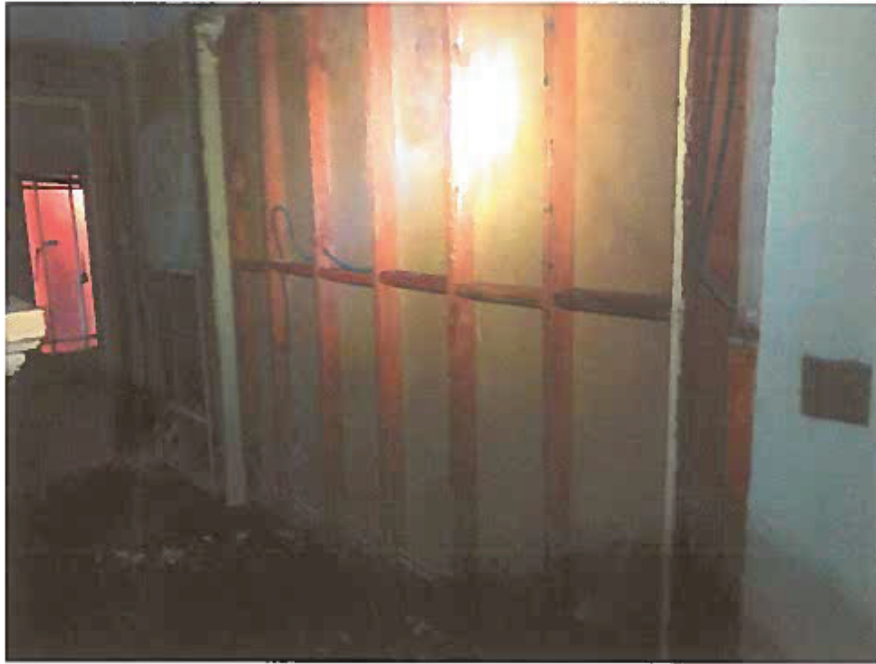
Photo 9 – Fireplace Hallway post-abatement

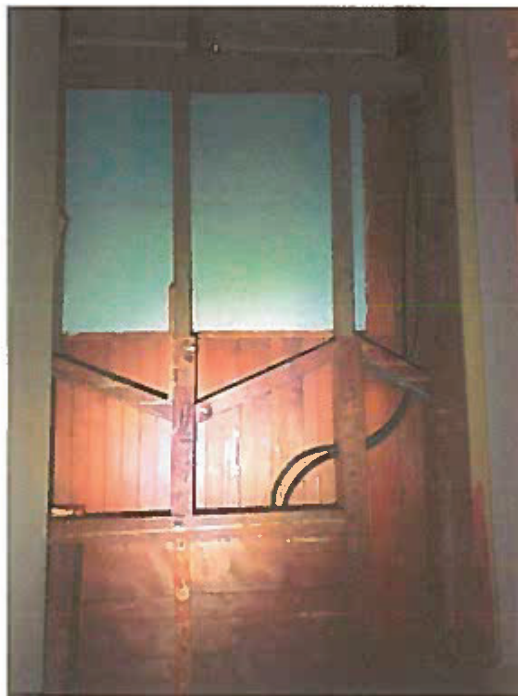
Photo 10 – Fireplace Hallway post-abatement

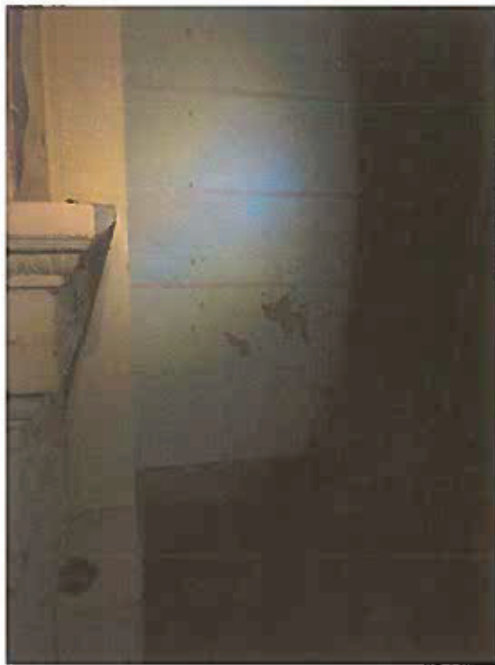
**Photo 11 – Fireplace Hallway post-abatement**

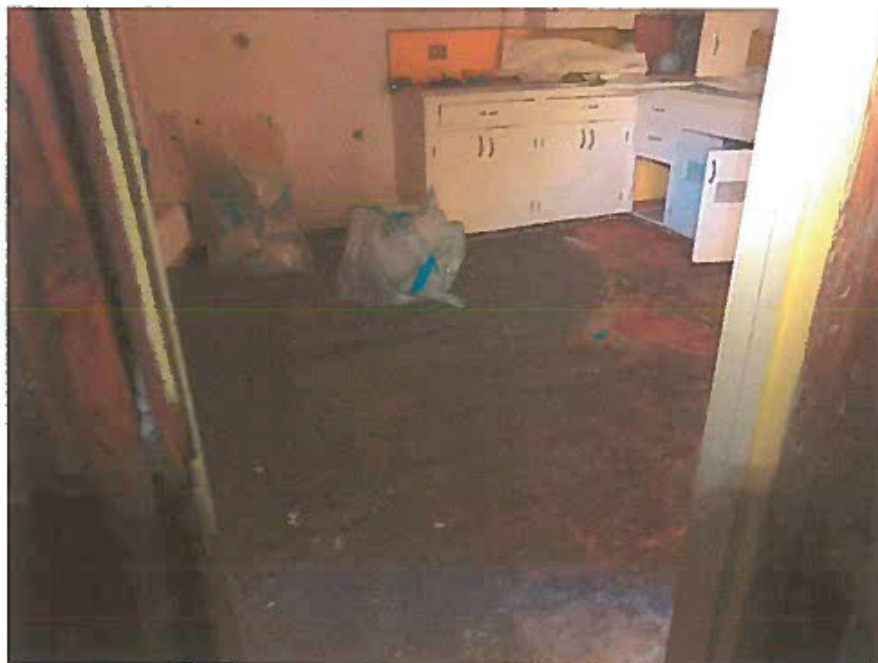
**Photo 12 – Kitchen post-abatement**

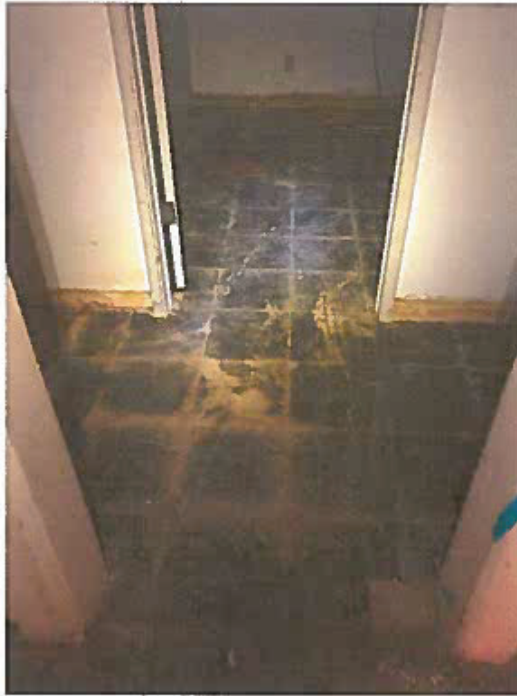
**Photo 13 – Hallway leading to Northeast Room post-abatement**

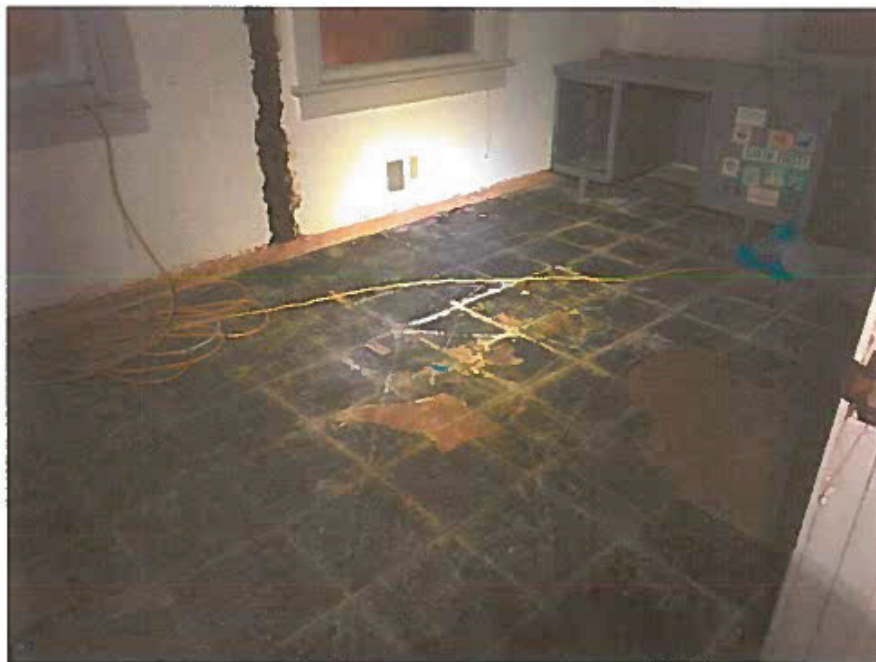
**Photo 14 – Northeast Room post-abatement**

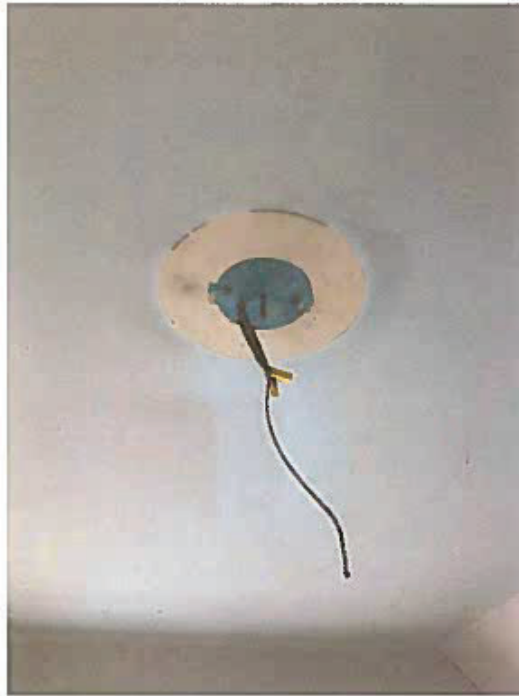
**Photo 15 – Light fixture post-abatement**

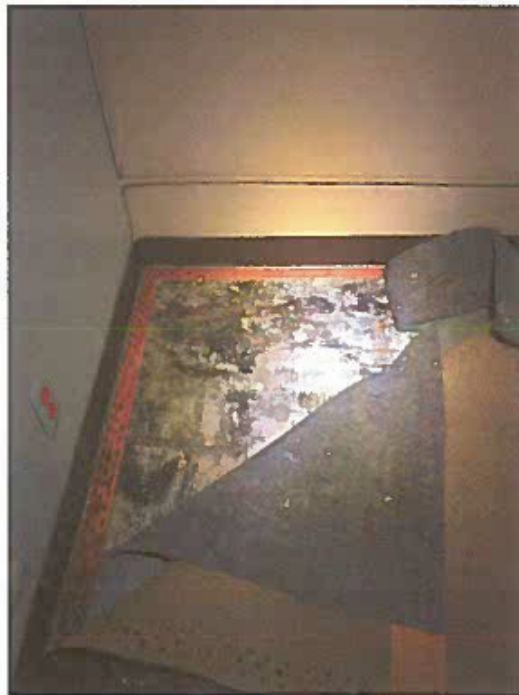
**Photo 16 – No vinyl floor tile in Basement**

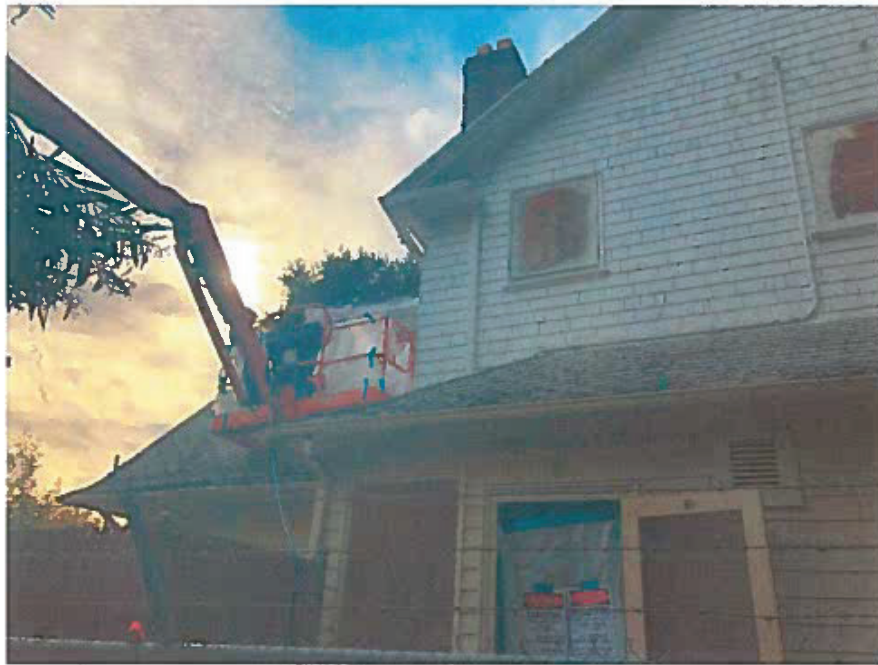
**Photo 17 – Painting second story**

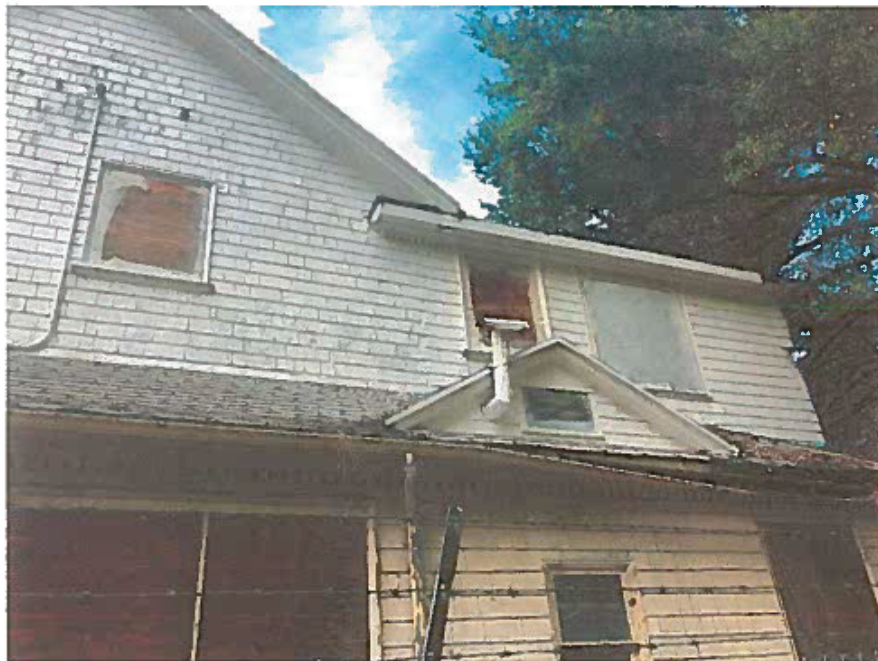
**Photo 18 – Paint work on second story**

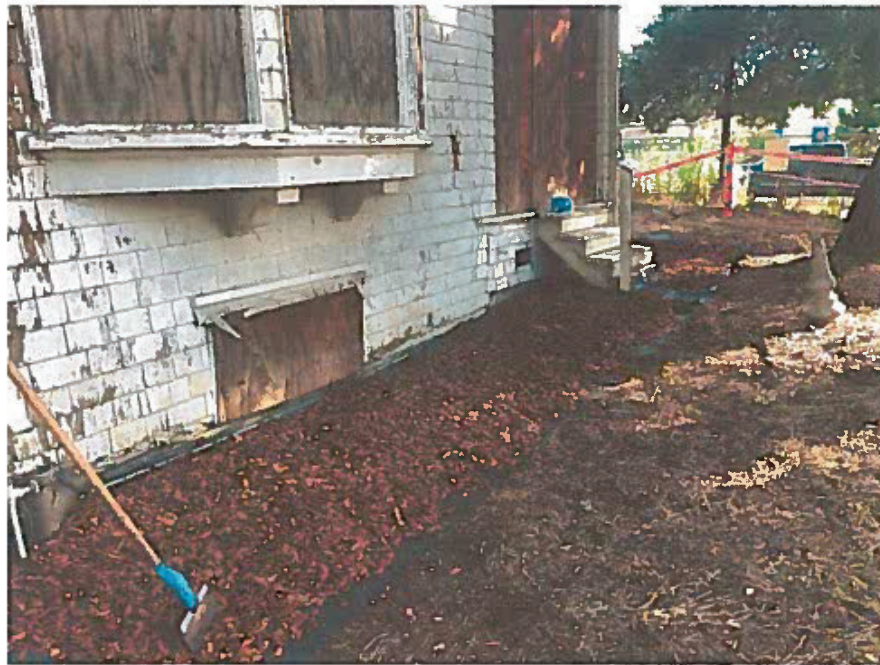
Photo 19 – In process of laying woodchips and fabric barrier

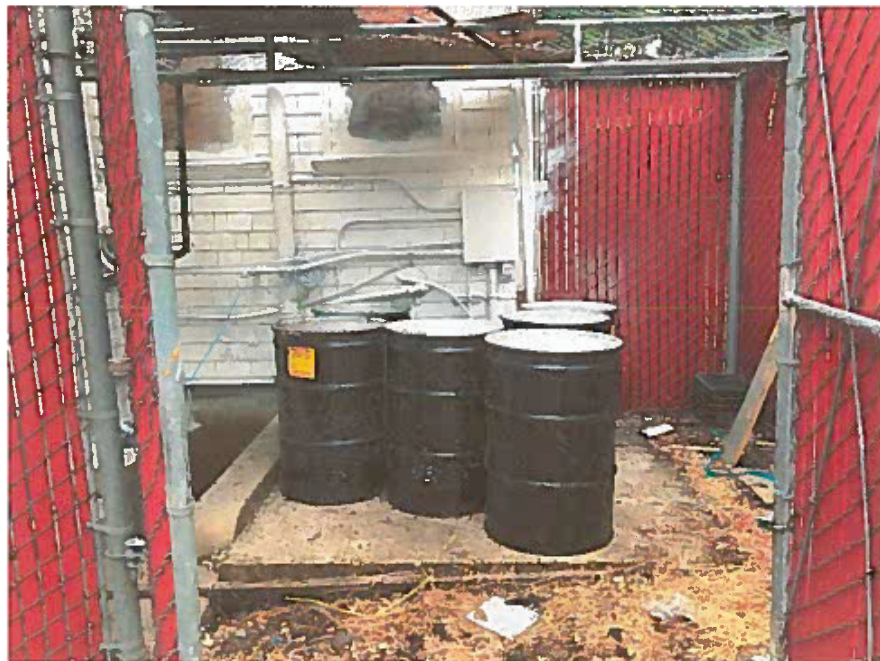
Photo 20 – Lead drums staged in locked area

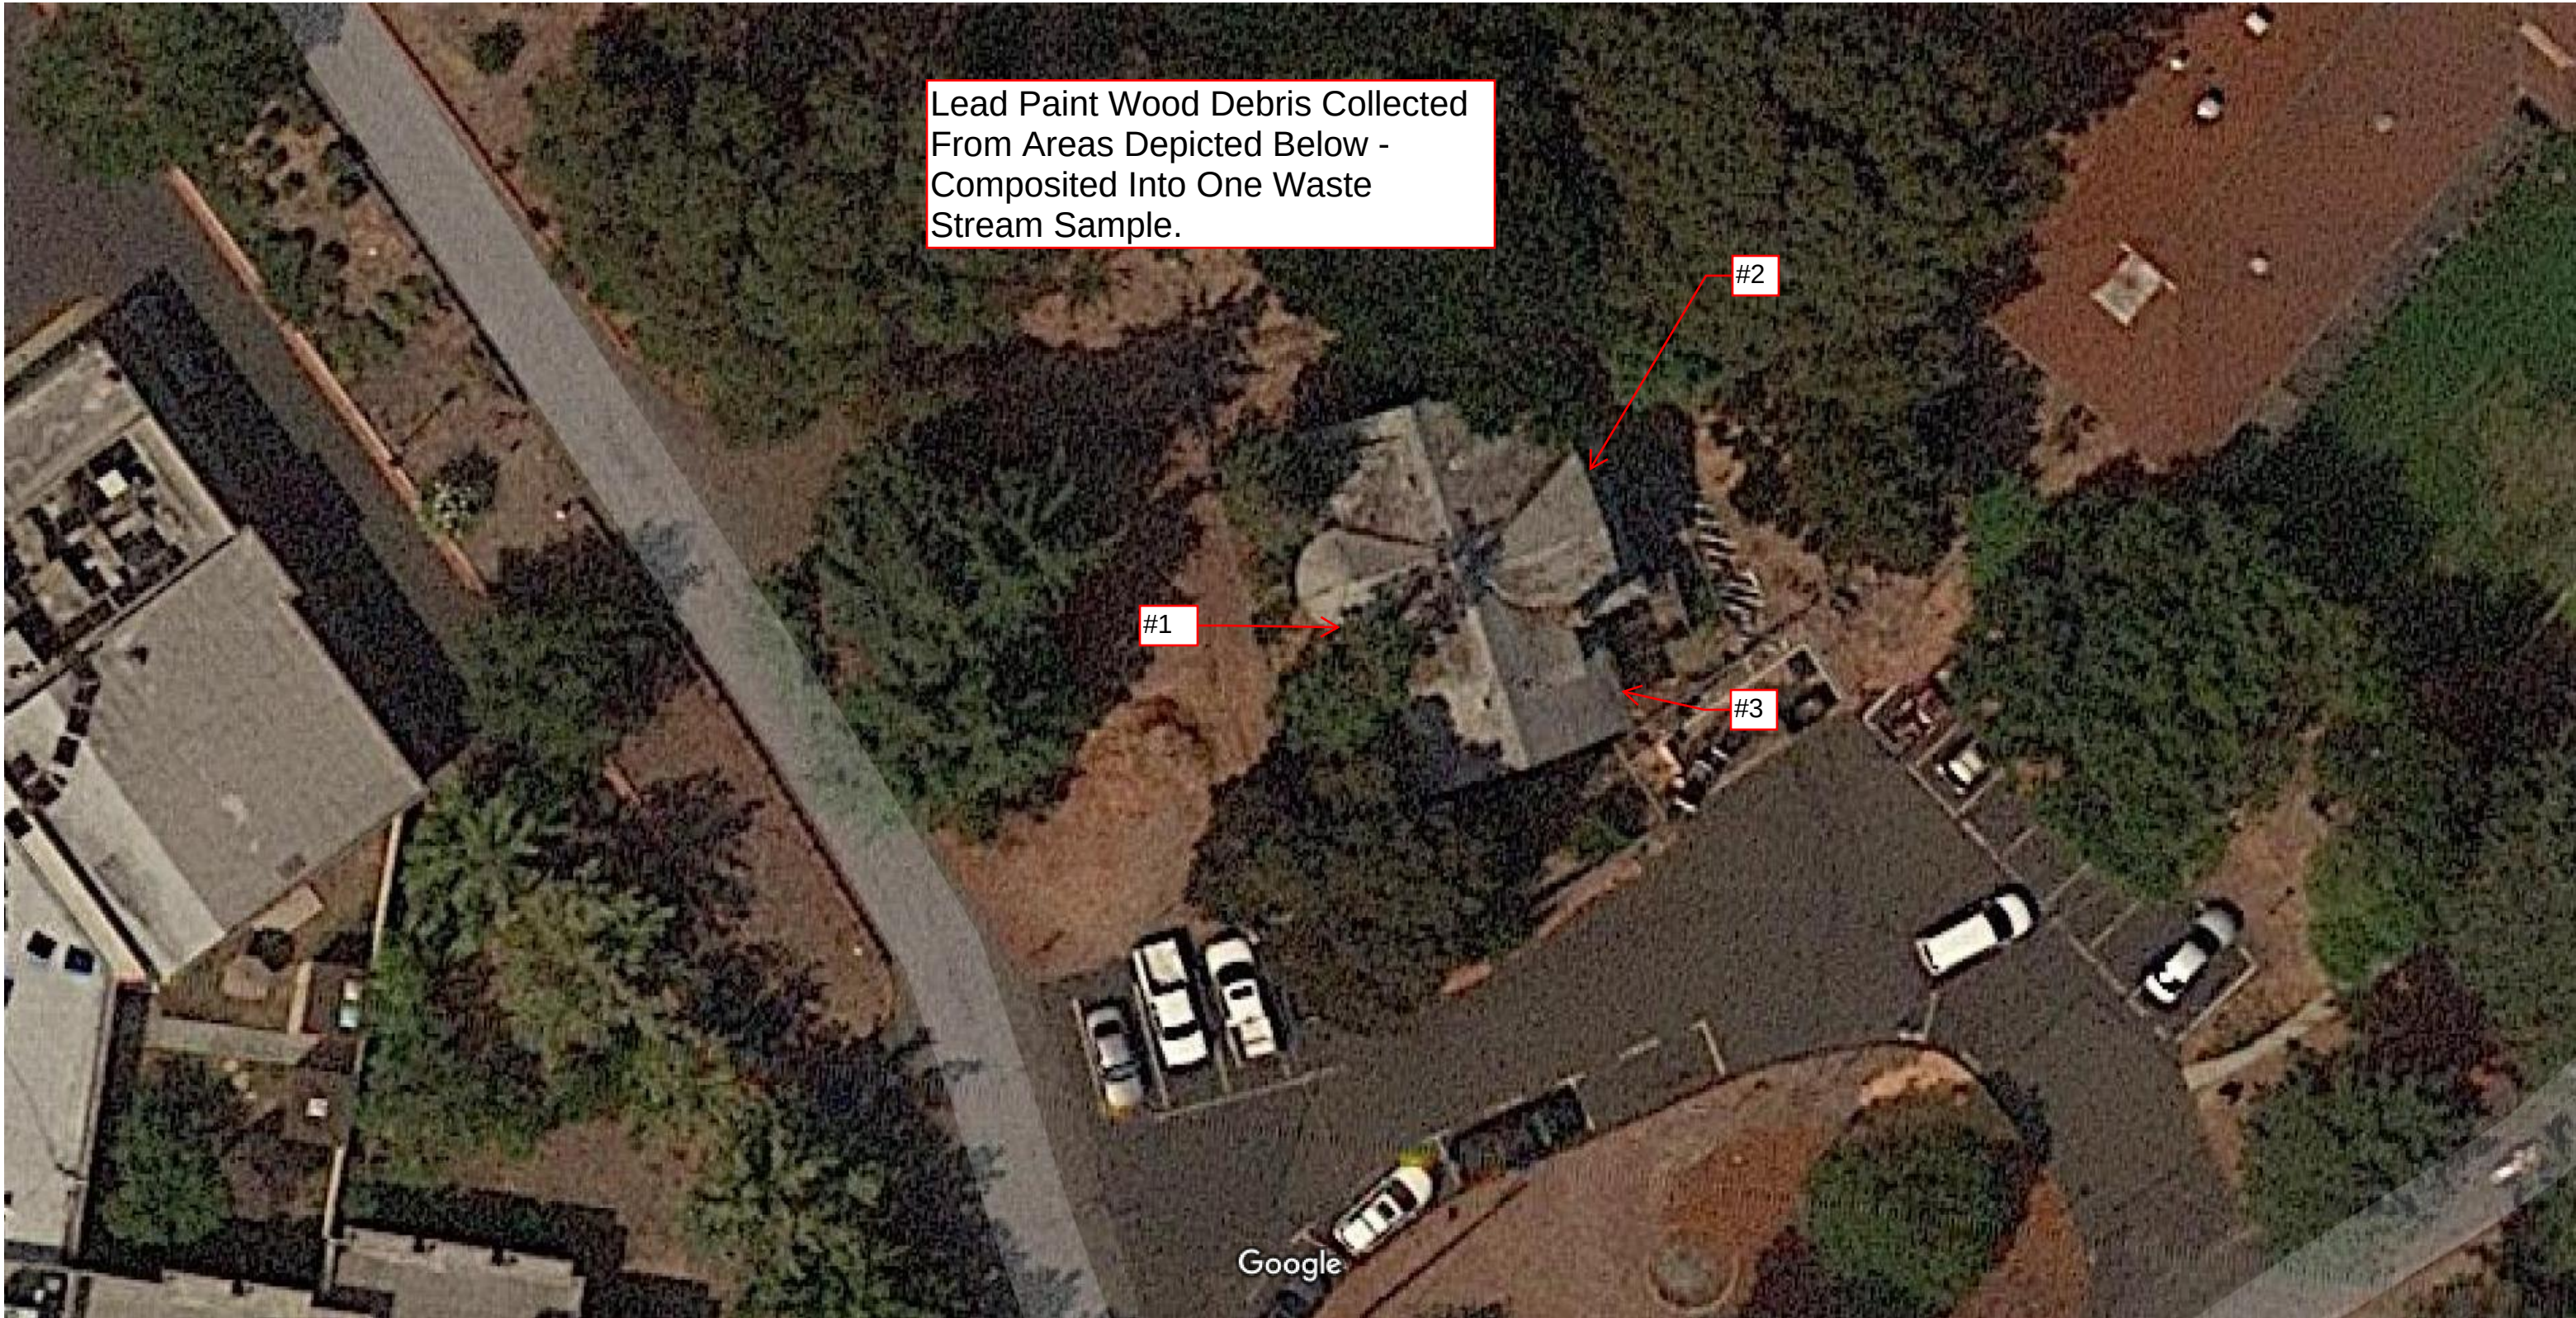
Lead Paint Wood Debris Collected  
From Areas Depicted Below -  
Composited Into One Waste  
Stream Sample.
